FALL 2021 MARINE INCIDENT SUMMIT

CASUALTY SUMMARIES

MSU HUNTINGTON

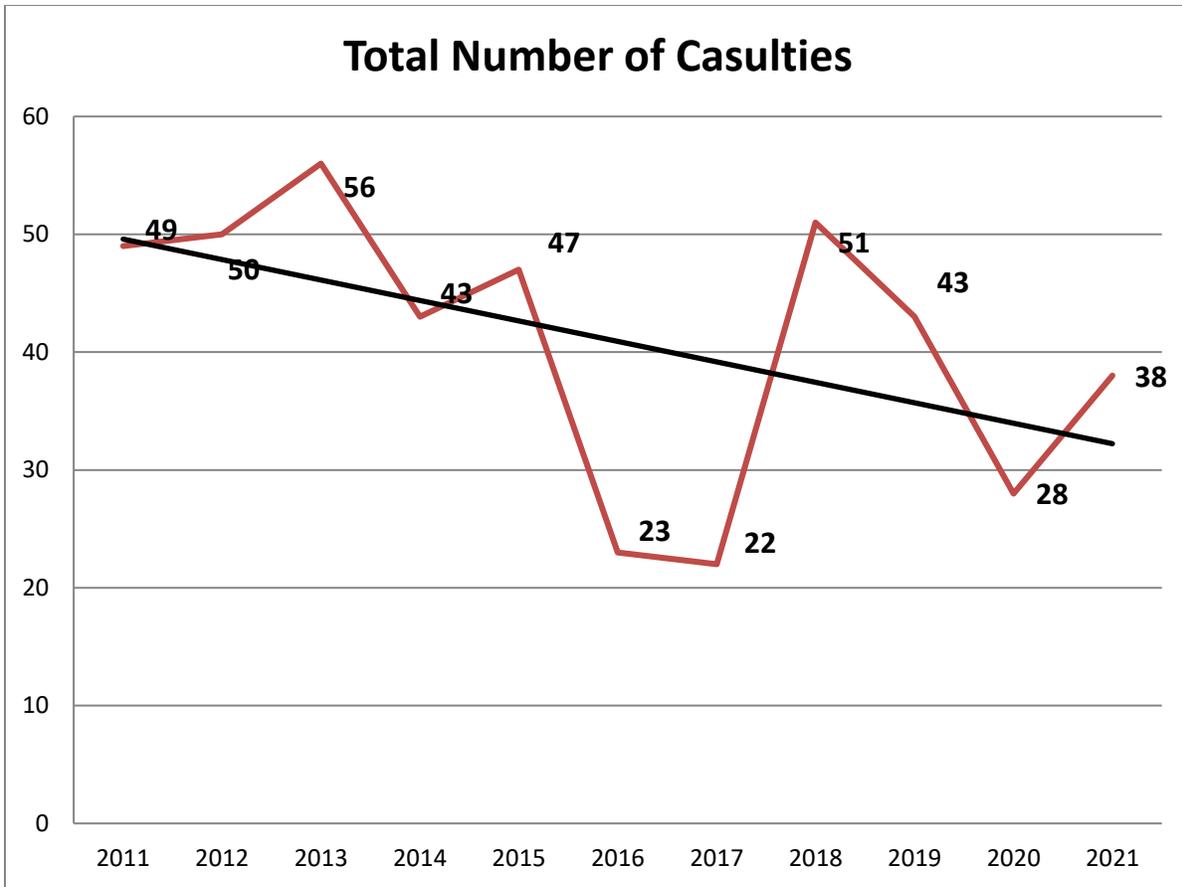
This graph represents the past 10 years of incidents investigated within MSU Huntington's AOR.

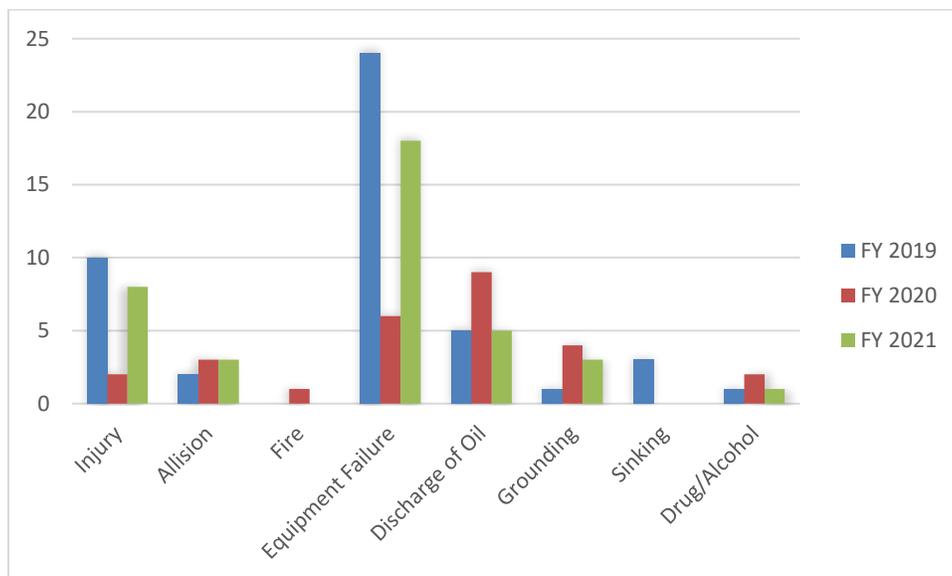
This table represents reportable marine casualties investigated within MSU Huntington's AOR for the past 3 fiscal years.

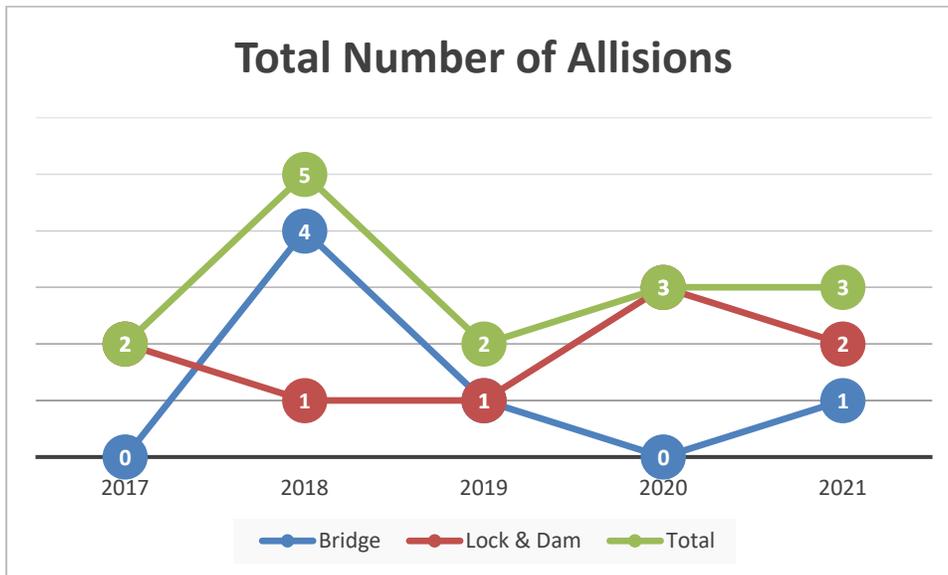
This graph represents the past 5 years of allisions that occurred in MSU Huntington's AOR.
